The Locomotive

THE HARTFORD STEAM BOILER INSPECTION AND INSURANCE CO.

INDEX TO VOL. 42—1938-1939

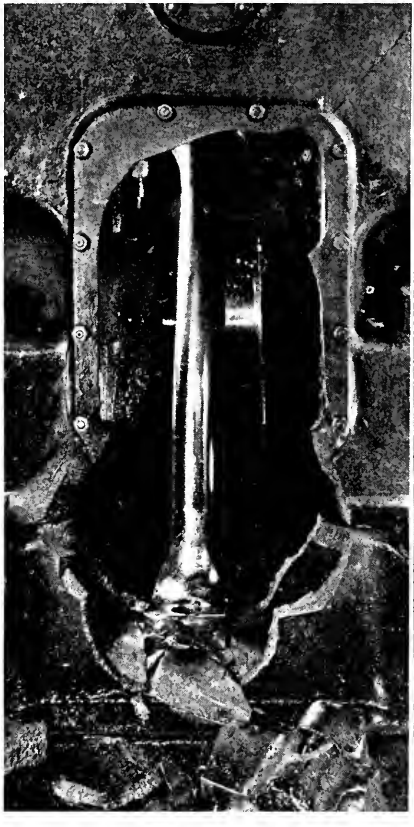
Figure 4—Left—Crankbolt breakage in a 260 hp Diesel engine. Figure 5—Right—Broken connecting rod and other damage on a 600 hp engine. This accident was caused by failure of a crankbolt, which had been in use for approximately 30,000 operating hours.

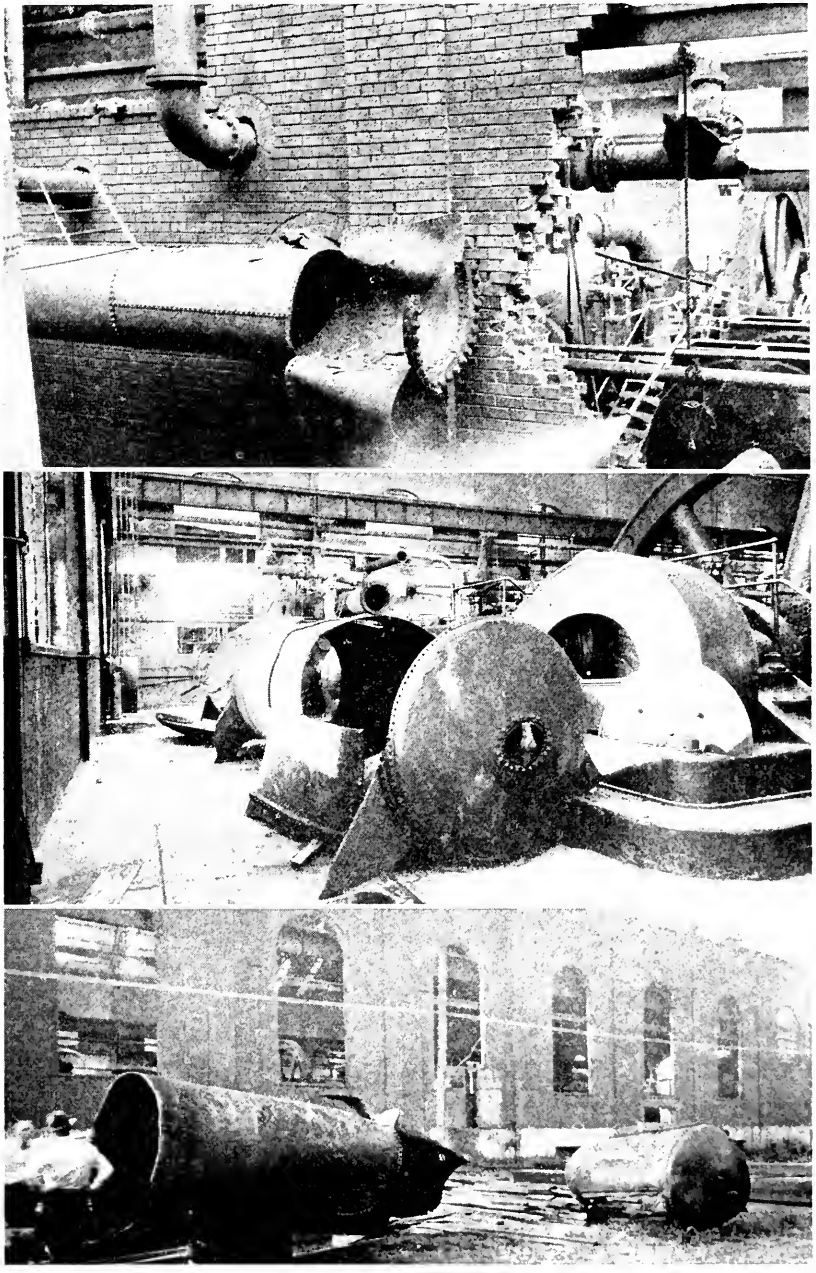
Results of a combustion explosion in an air line and two large air receivers.

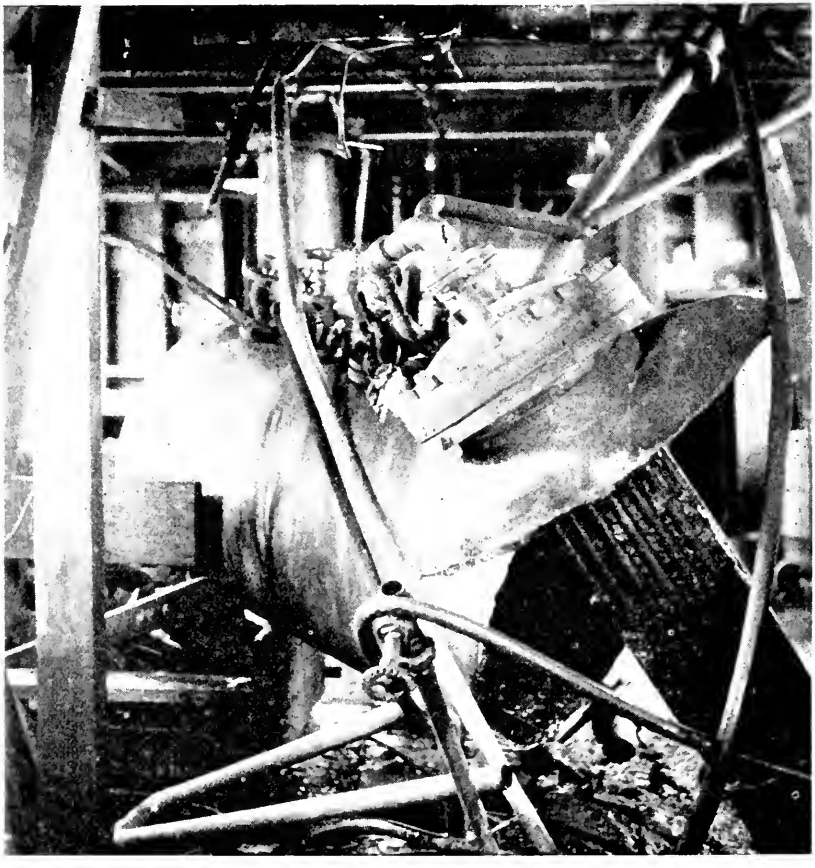
Damage after a combustion explosion in a chemical process tank.

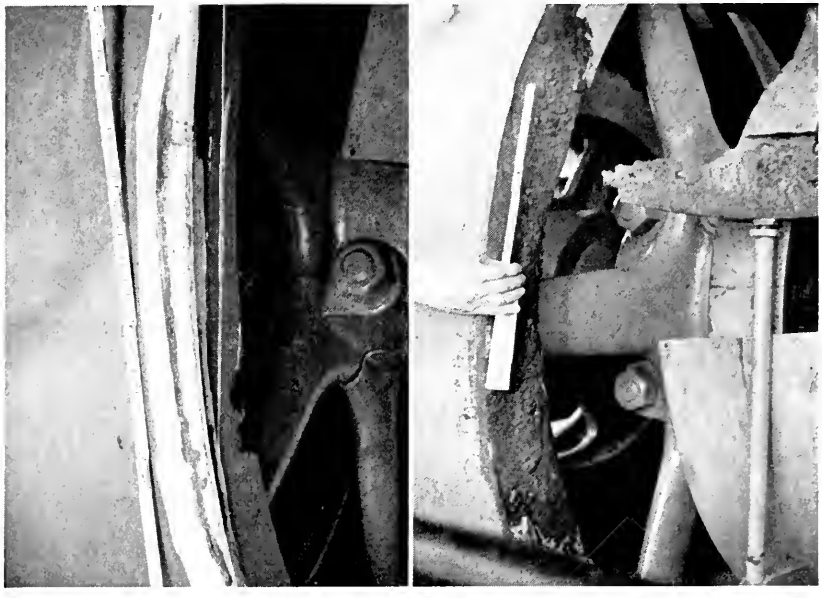
The illustrations show a casting defect in a 40-year-old flywheel. The engine on which this wheel was used had not been in operation for two years as it was kept as a stand-by for emergency service. It was given a test run each week.

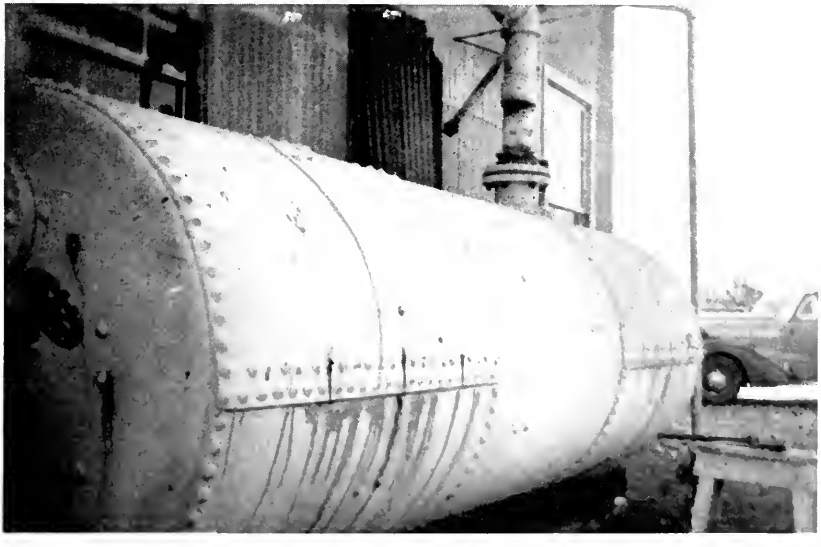
Possible explosion of this air tank was averted when hidden cracks were found by slotting the seams.

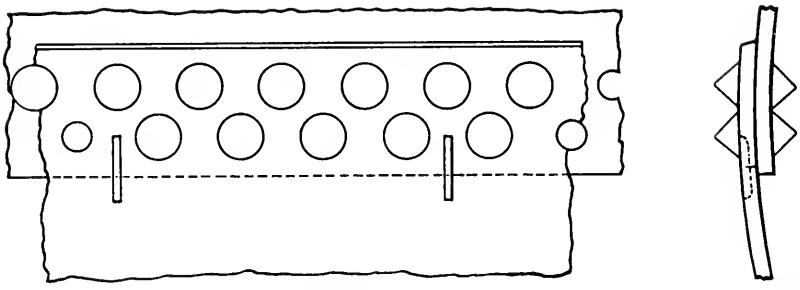
Drawing of a lap-riveted joint showing method of testing the outside plate for hidden cracks.

seams of lap-riveted boilers. Although it has not been used generally for unfired pressure vessels of similar riveted construction, there are cases, as in this one, where it is applicable and effective. Previous articles in THE LOCOMOTIVE have given accounts of explosions resulting from lap seam cracks and have also described the procedure for making the investigation. Briefly, the method consists of chiseling or milling a series of slots (about 1½″ long and ¼″ wide) two-thirds or more through the plate and spaced about 1′ apart along the line of rivets. The drawing on this page illustrates the relation of the slots to the seam. Such slots will not appreciably weaken the strength of the joint but will reveal whether a lap-seam crack exists, either by leakage during a hydrostatic test or by the crack being visible in the bottom of the slot.

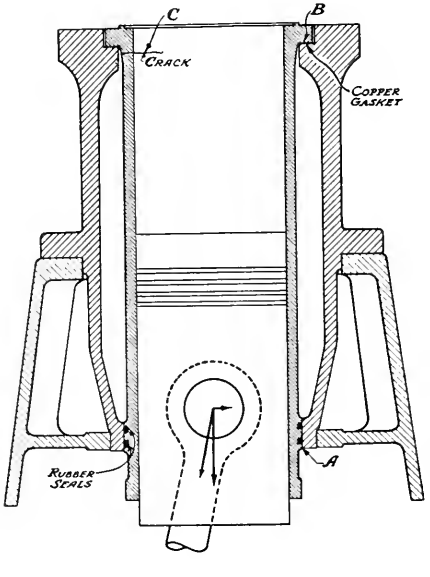
Cracks of this sort seldom run longitudinally but almost always circumferentially and are found at a distance of a few inches from the top of the liner—as at "C" in Figure 1. This drawing shows a typical design of removable cylinder liner and the usual method of liner support in the cylinder block.

There are a number of different causes for the formation of these slow-forming cracks. One of them is the uneven bolting down of the cylinder heads. It is well understood by erectors and operating engineers of Diesel engines that this bolting down must be done with care and that the bolts must be set up uniformly. However, the mistake is occasionally made of tightening all the bolts on one side before tightening any of those on the opposite side. This imposes a bending strain on the top of the cylinder block, which strain is transmitted to the liner, tending to distort and bend it out of shape.

Figure 1—Typical design of removable cylinder liner showing the usual method of liner support in the cylinder block.

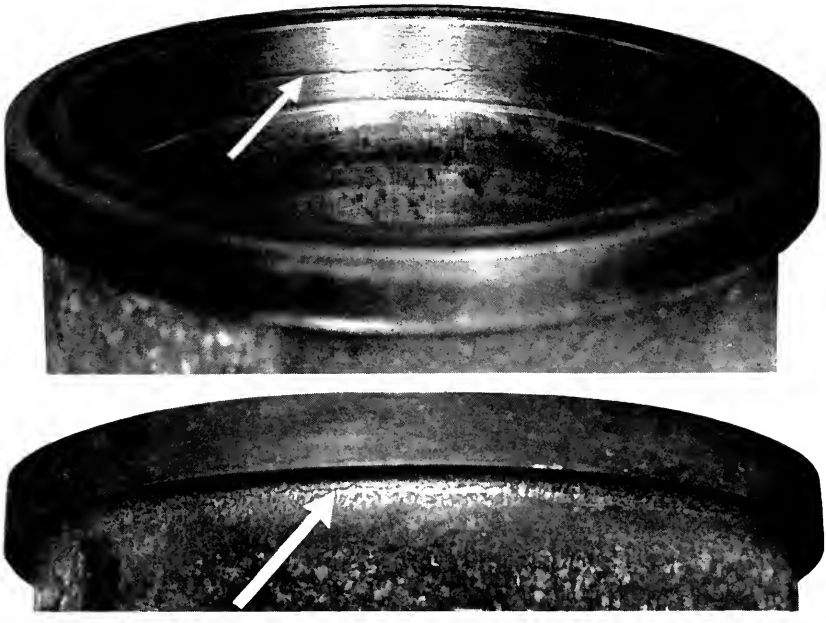
Figure 2 and 2A—Views showing a circumferential crack near the top of a 15″ cylinder liner. This crack permitted leakage of water into the cylinder.

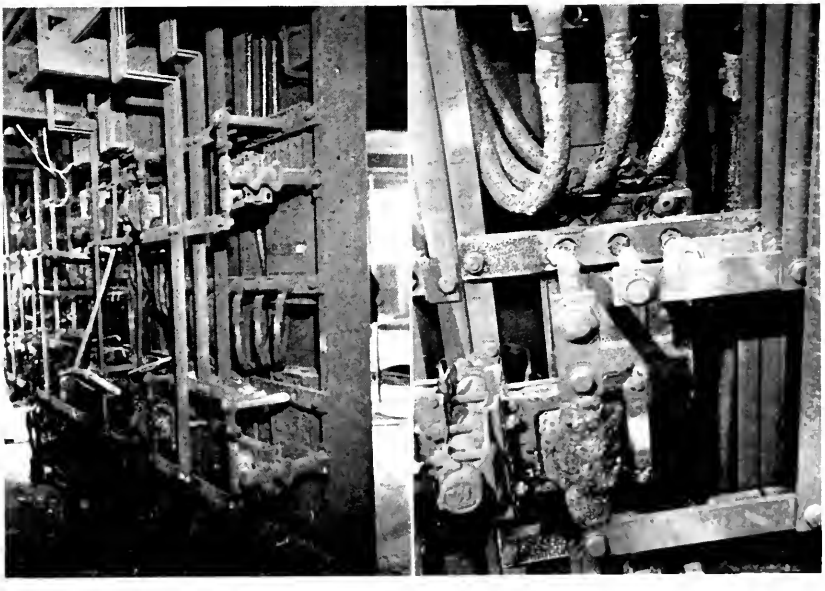
Left—Back of a seven-panel switchboard badly damaged by phase to phase short circuit and by ensuing fire.

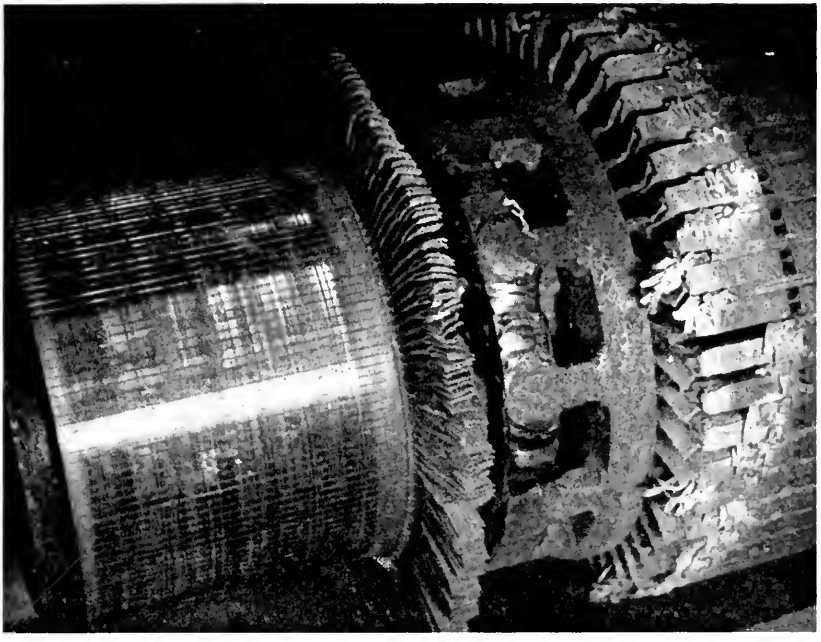
Breaking of the band wires on the commutator end was found to have caused the damage to this exciter armature of a 30,000 kw turbo-generator set. The winding between the armature core and the commutator risers was completely destroyed. The resultant arcing burned the iron and laminations of the core and also set fire to the insulation. Estimated cost of repairs, which consisted of rewinding the armature and the field, rebuilding of the commutator and replacing the burned iron and laminations in the core, was $3,000.

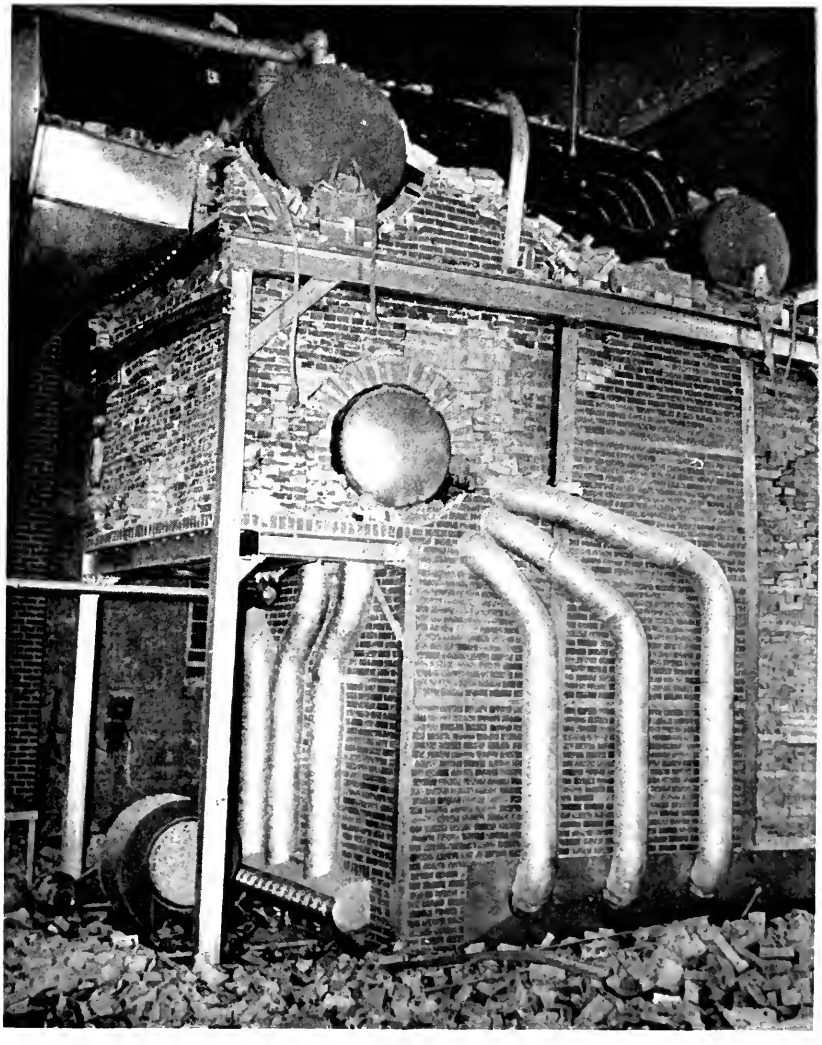
The damage to this large water tube boiler fired with natural gas was caused by a furnace explosion.

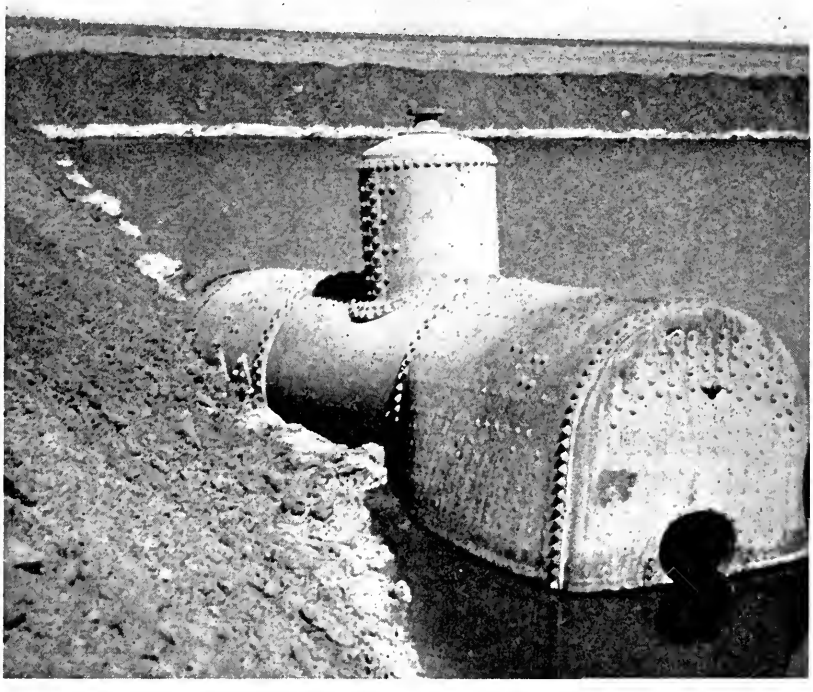
This locomotive fire box type boiler soared to the above location 250 feet from its setting in a California oil field when the crown sheet dropped because of low water and over-heating. A boiler attendant was scalded.

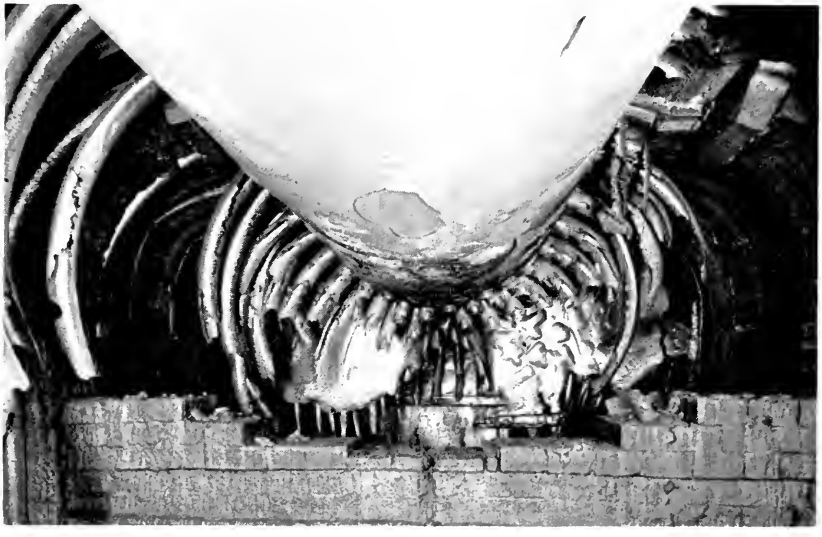
Damage to this water tube boiler was reported to have been caused by overheating when the feedwater was shut off and the automatically controlled stoker continued in operation. Installed about 7 months previously at a cost of $12,000, the boiler was so badly burned that replacement was necessary.

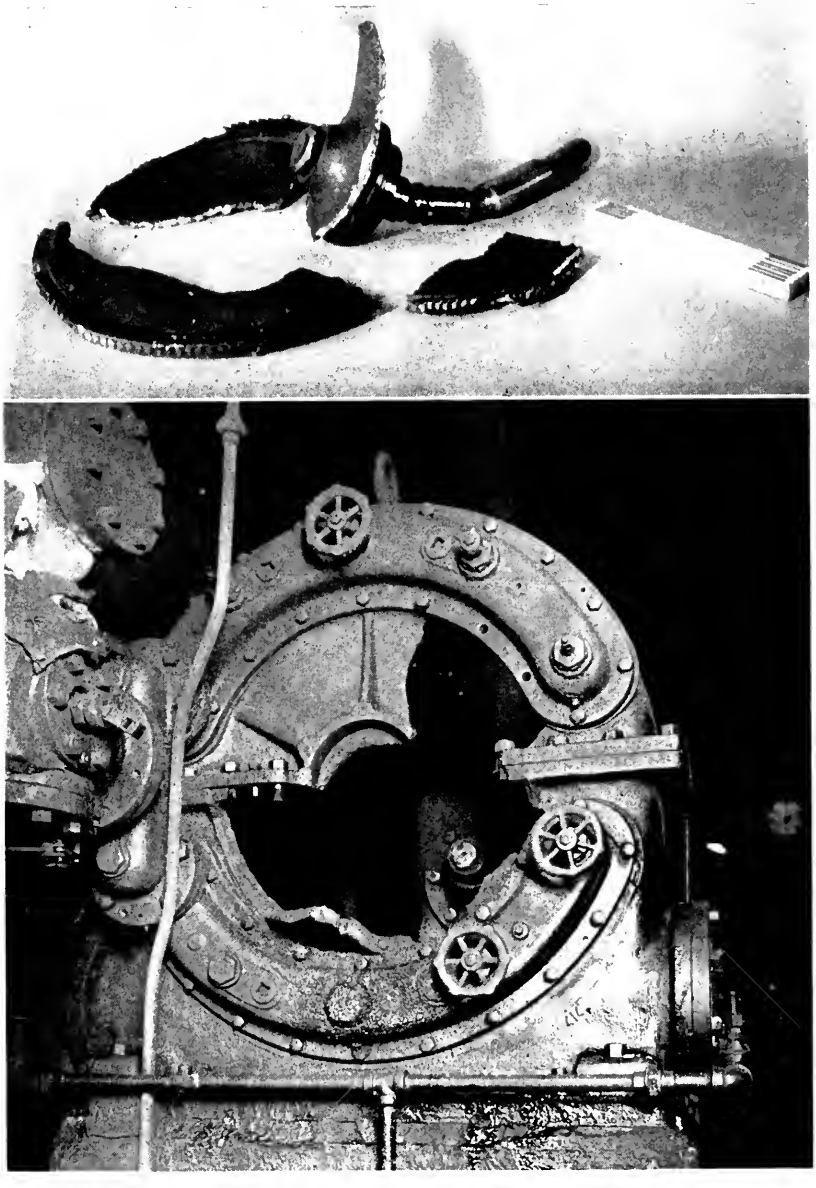
Top—Two men were injured when the rotor—pictured above—of a small steam-turbine burst from excessive speed.

Bottom—Explosion of this steam-turbine draft-fan unit was attributed to overspeed after the load was lost.

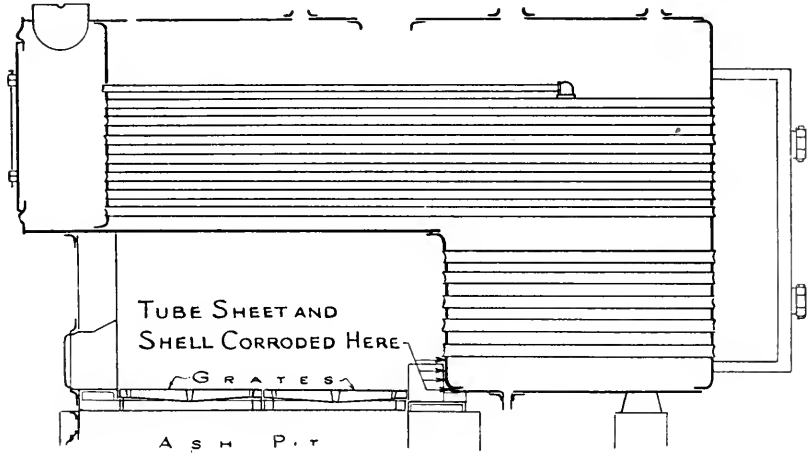
Figure 3—Drawing of an economic-type boiler indicating areas concealed by grates or brickwork where external corrosion is likely to occur.

Figure 4—Wreckage at a steel mill following an explosion of a water tube boiler. Caused by external corrosion of one head of the lower drum which had been concealed in brickwork, the explosion killed two people and injured five others. Property loss was about $75,000.

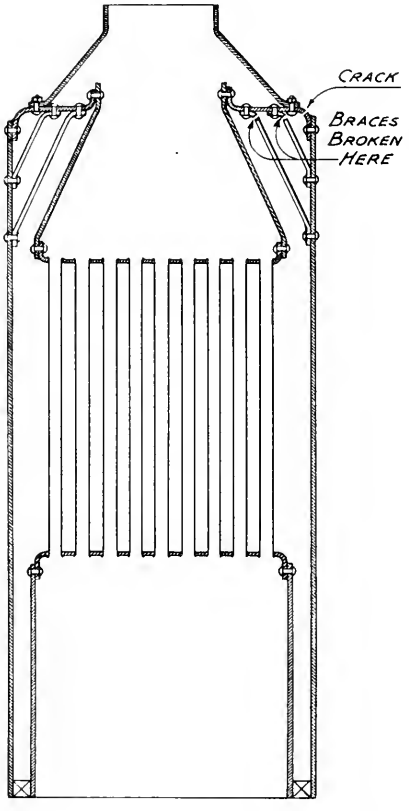
When the top head of a small vertical tubular boiler tore open along the flange three men were badly scalded. Examination of this head, following the failure, disclosed that a previous crack in the head at the point of failure had been poorly repaired by welding. Ten braces supporting the head either had been broken or the rivets had sheared off. Probably some of these braces had been broken prior to the original cracking as the breathing or bending action of the unsupported plate would tend to crack the metal along a line where the rupture occurred. Figure 5 shows that an internal inspection of the upper section of the boiler could not be made unless the tubes were removed as there were no openings in the head or shell. This sketch also illustrates the importance of removing the smoke hood periodically unless there is an opening through the hood sufficiently large to permit access for external inspection in this area.

Figure 5—Three men were badly scalded when the top head of a small vertical tubular boiler, similar to the one drawn here, tore open at the flange along the line of a previous crack.

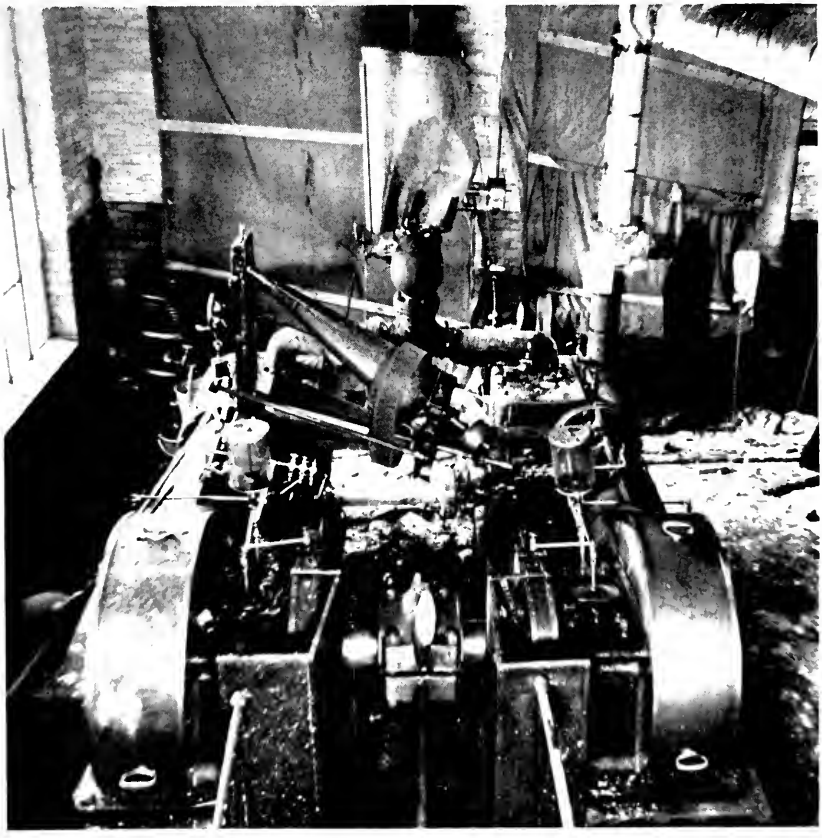
View of the steam engine showing the wreckage following the explosion.

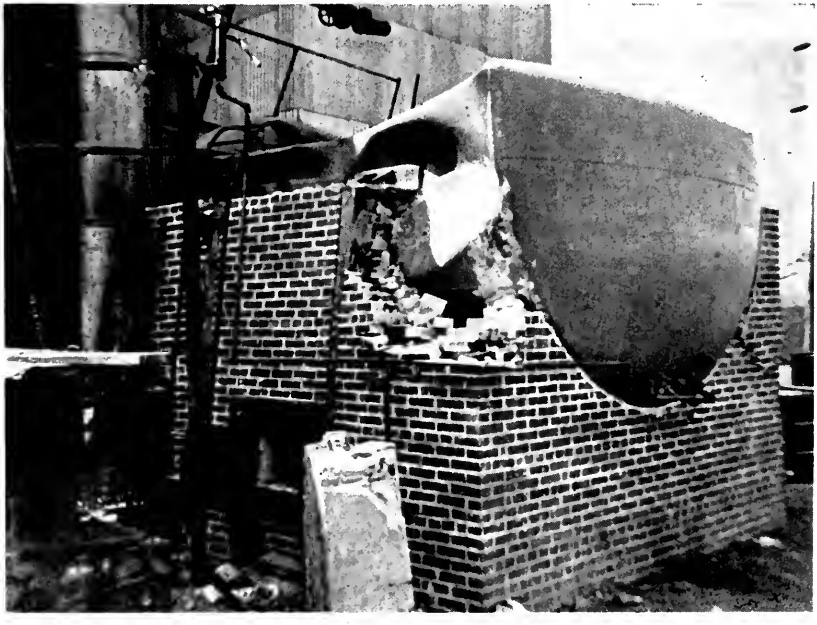
View of a large tank after it had collapsed while being given a vacuum test.

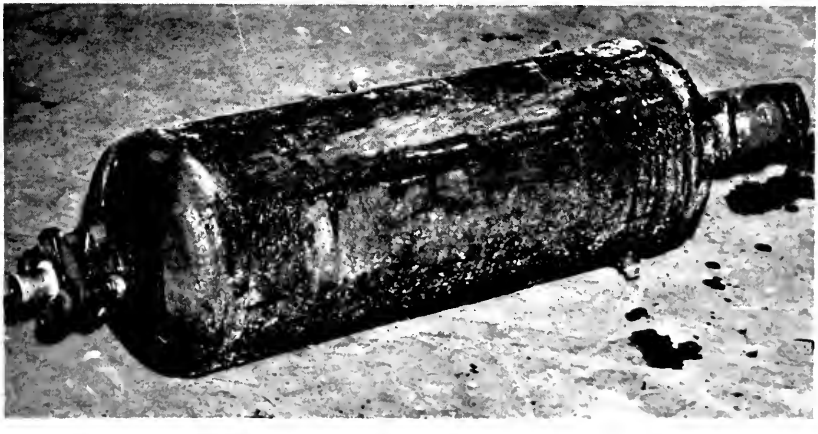
Figure 1—Five men were injured (three of them fatally) by the rupture of this ammonia receiver along a welded seam. Overpressure from expansion of the ammonia when an acetylene torch was used to cut a connected pipe was the probable cause of the failure.

to have been pumped out of the receiver before the work was started. One of the men was cutting a connected pipe line with an acetylene torch while the others were unbolting the receiver supports when the vessel suddenly burst along a welded longitudinal seam as shown in Figure 1.

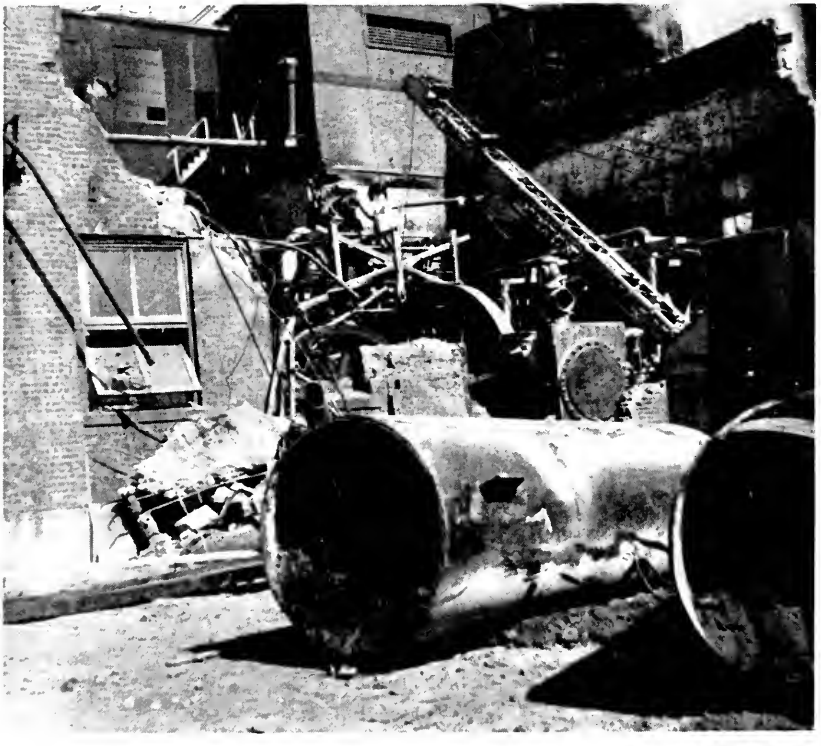
Figure 3—Power plant for a packing company wrecked by an explosion and fire after a fitting ruptured in an ammonia discharge line of a large refrigerating system.

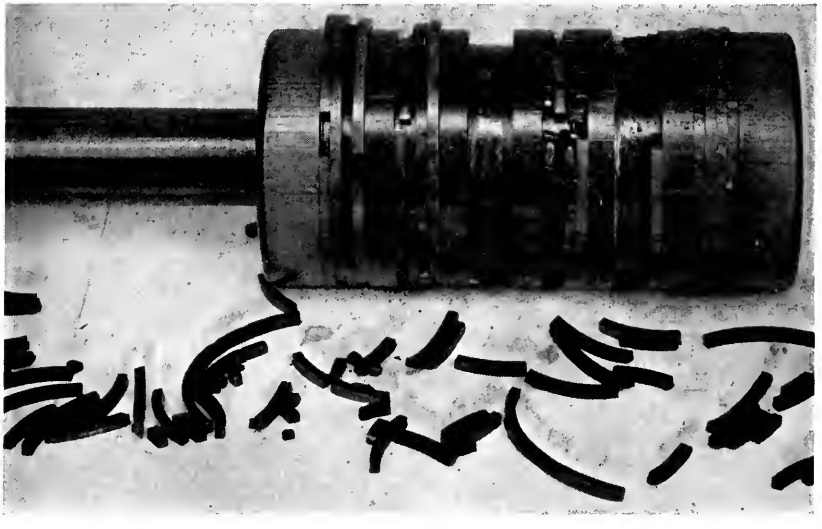
Figure 5—Carbon-dioxide compressor piston and rings damaged by a piece of valve spring which worked its way between the piston and cylinder wall.

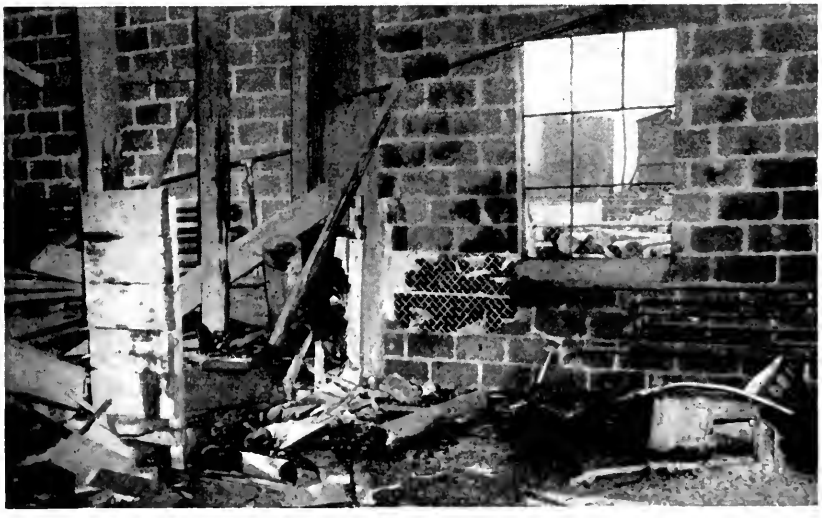
Figure 3—After an explosion of a cast iron hot water heating boiler in a garage. Originally located adjacent to the hole in the rear wall, the base of the boiler was hurled several feet to the right.

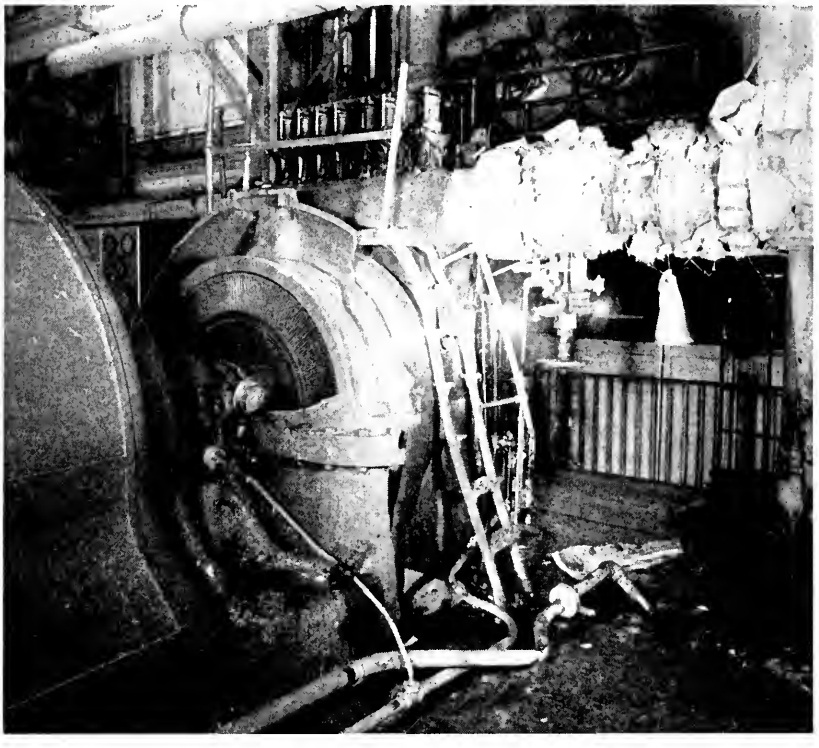
Steam turbine wrecked by an explosion when its exhaust casing burst from excessive steam pressure.

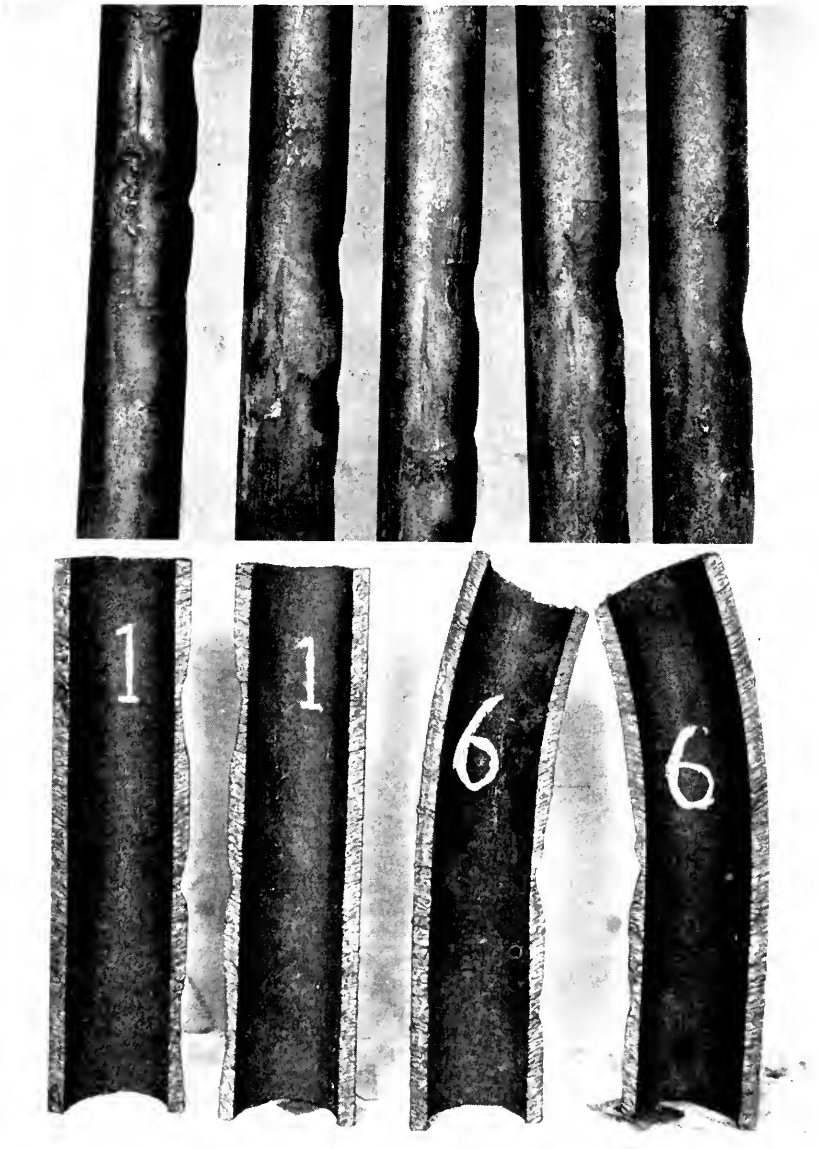
Top—Tubes in a water tube boiler eroded by steam from a soot blower. Previously, shields had been welded to these tubes to stop the erosion but they proved ineffective.

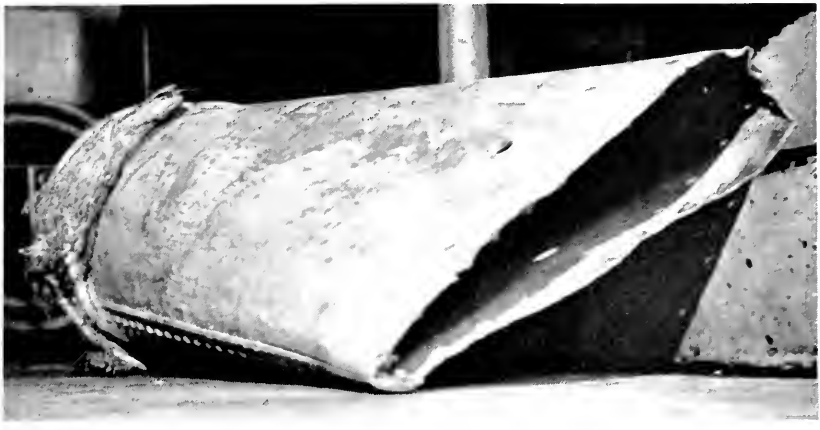
Figure 1—Over-pressure caused explosion of this hot water tank in a laundry. The property loss was over $5,800.

Figure 1 shows a picture of a new hot water tank after it had exploded from over-pressure. This failure occurred in a cleaning plant and resulted in damage amounting to more than $5,800.

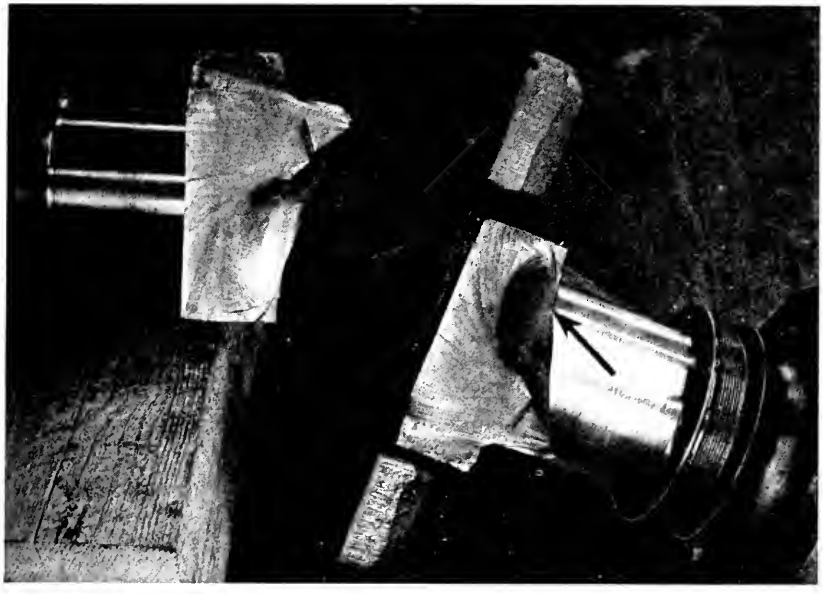
Broken crankshaft on an 180 hp Diesel engine which had been operated only 1000 hours. The failure lines in the surfaces of the break show that it started with a small crack on the main-bearing side of the web (see arrow) and also clearly indicate the progress of the crack through the web. Evidently caused by high local stress produced by misalignment, this failure illustrates the value of timely and thorough inspections of Diesel engines. Many similar failures have been prevented by such inspections.

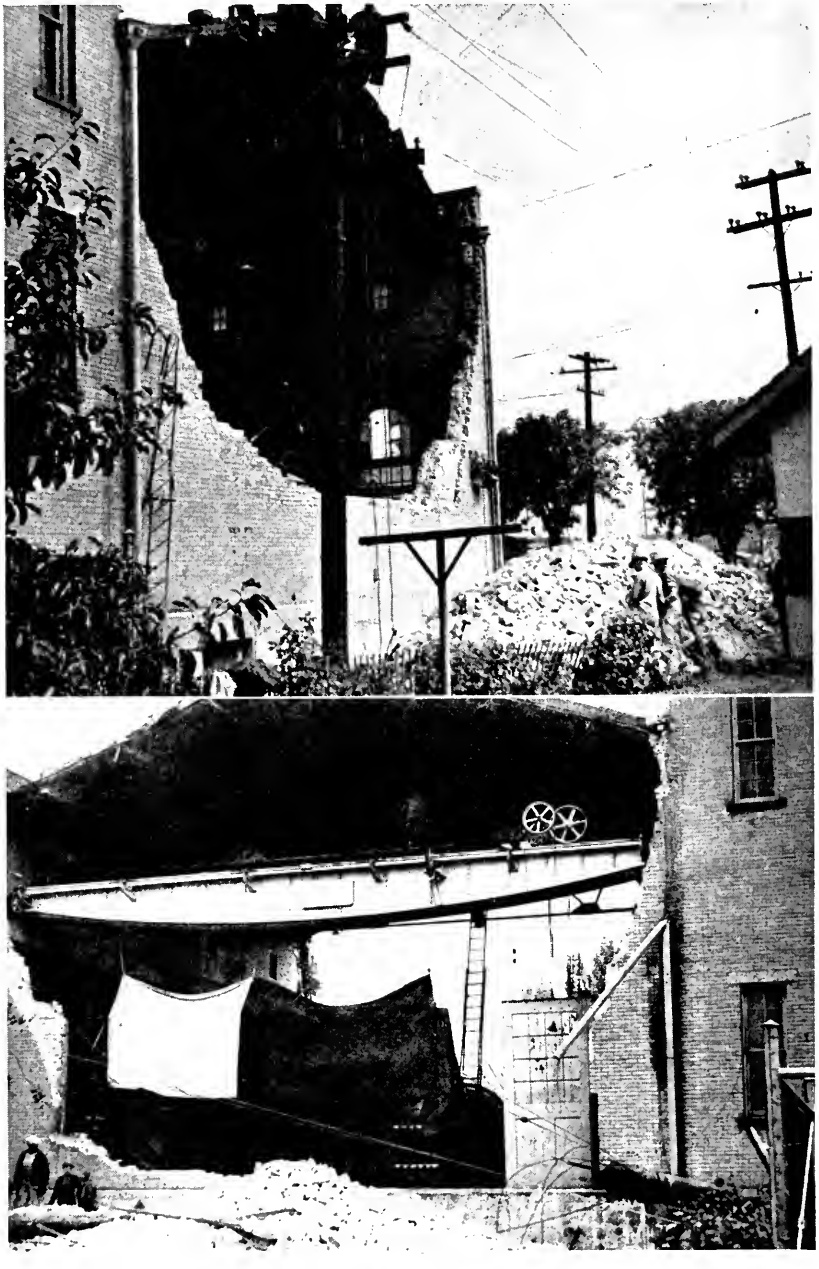
Two views of a utility sub-station after an explosion, caused by a direct stroke of lightning, blew out the end-walls.

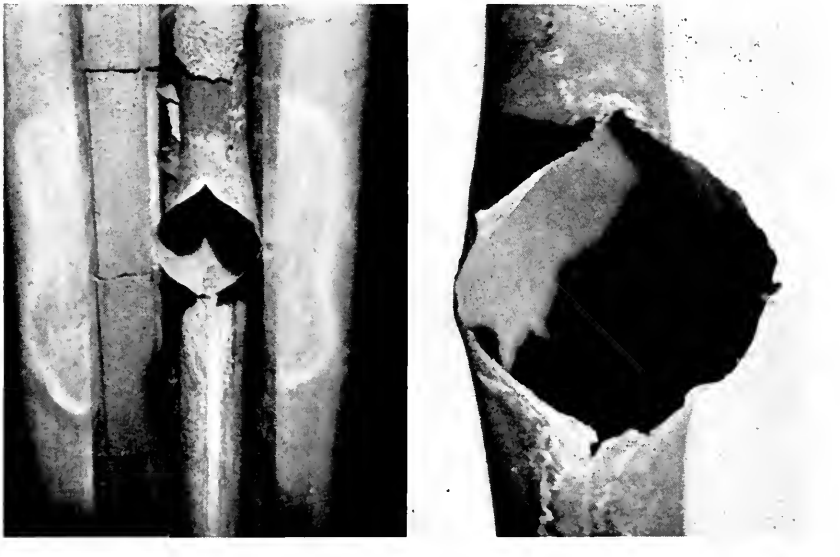
Two views of a ruptured tube for a water tube boiler reported to have been operated at a higher rating than that for which it was designed. Steam pocketed in the tubes, causing one of them to overheat and rupture. Because of the resultant loss of water and the high furnace temperature, 100 additional tubes were distorted and had to be replaced.

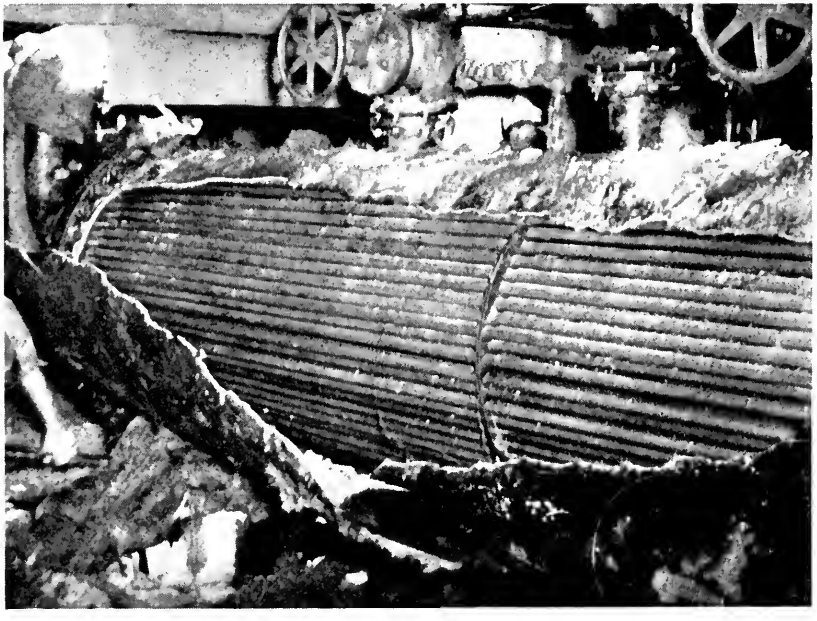
When this brine cooler exploded violently last August four men were seriously injured, one of them being burned so severely by ammonia that he died three days later. Estimated at more than $40,000, damage to the building and contents was caused principally by escaping water and ammonia.

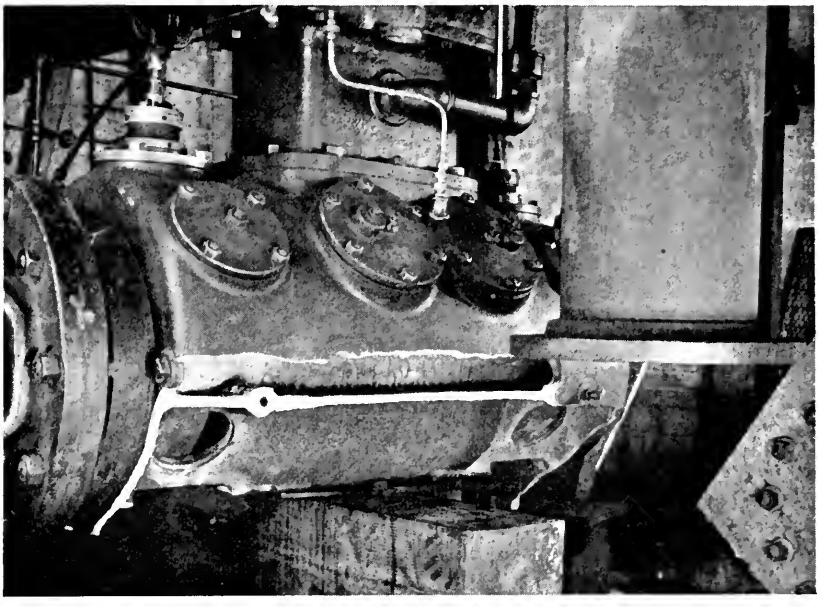
Figure 1—High pressure cylinder on a two-stage motor-driven air compressor damaged by an explosion. Excessive air pressure or a combustion explosion may have been the cause. The operating engineer was killed.

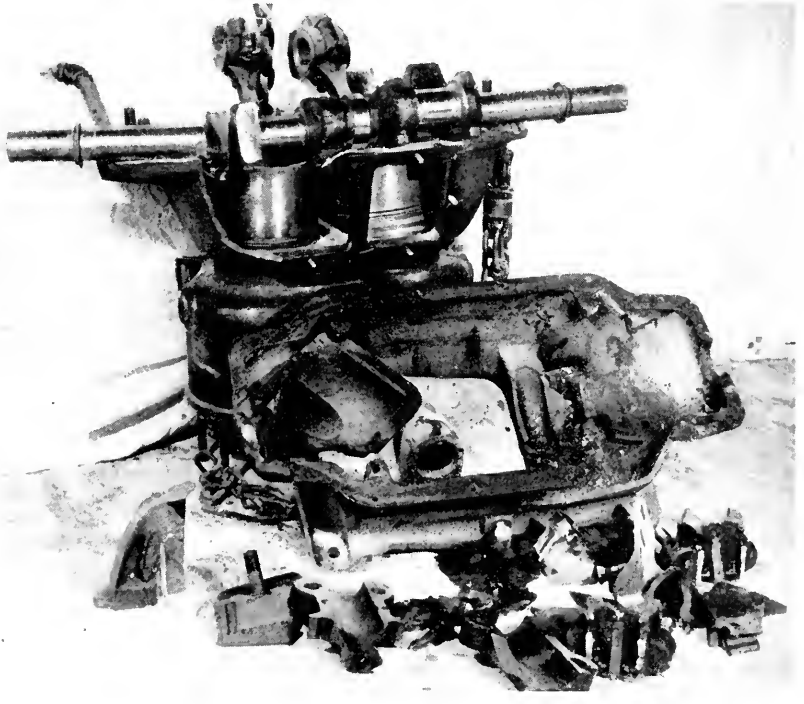
Figure 2—Vertical two-cylinder air compressor so completely wrecked when the crankshaft broke that repairs were impracticable.

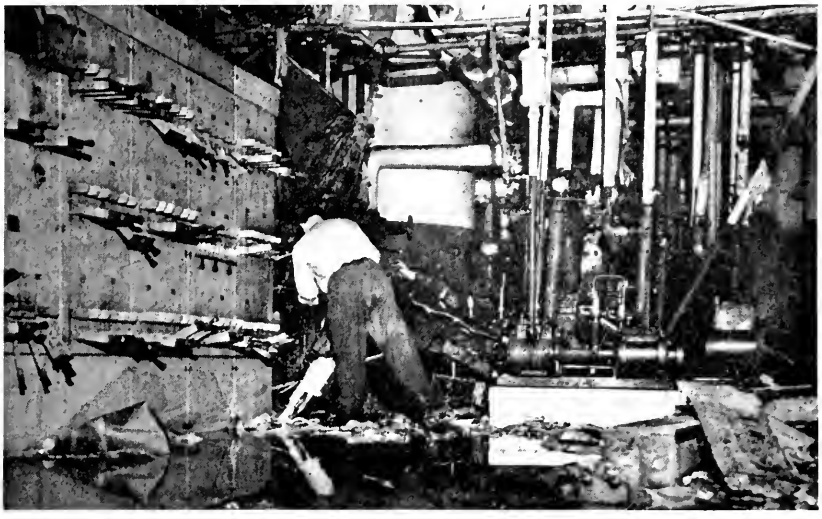
Some of the damage caused by an explosion of an open-type cast iron feedwater heater. Originally the heater was installed near the place where the man is standing and parts of it can be seen to the man's right and over his head. The explosion caused the death of 3 men and property damage of approximately $4,000.

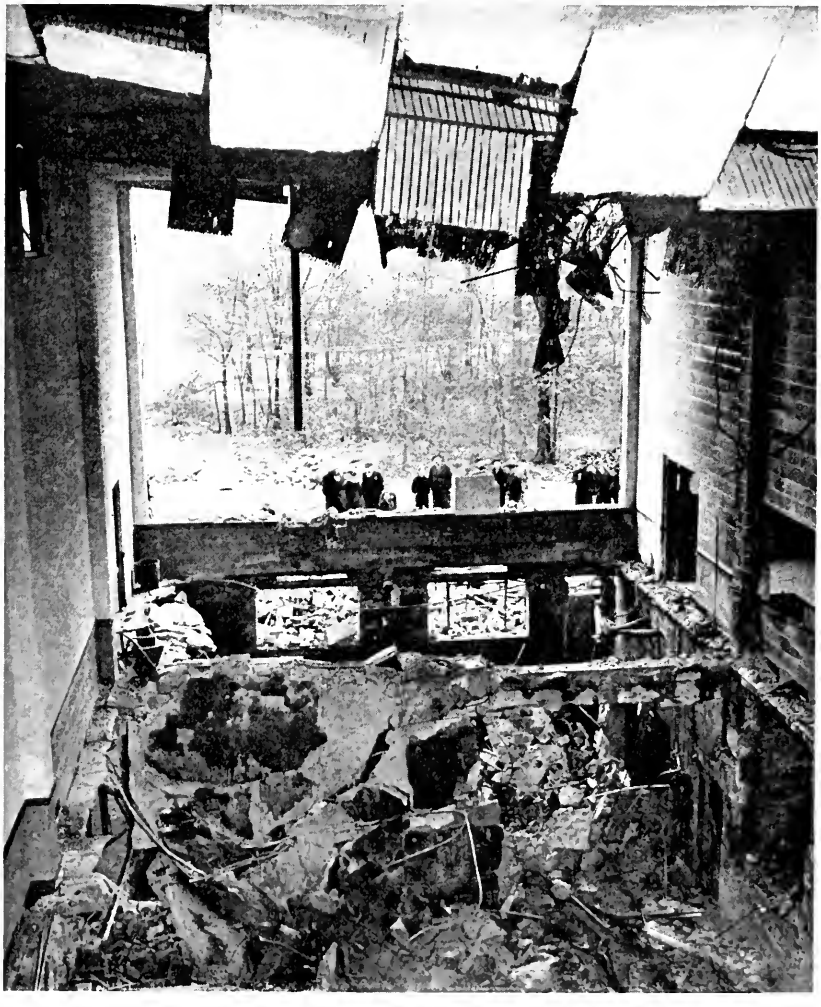
Pictured above are the ruins of a high-school study hall. An explosion of a hot water heating boiler caused this damage.

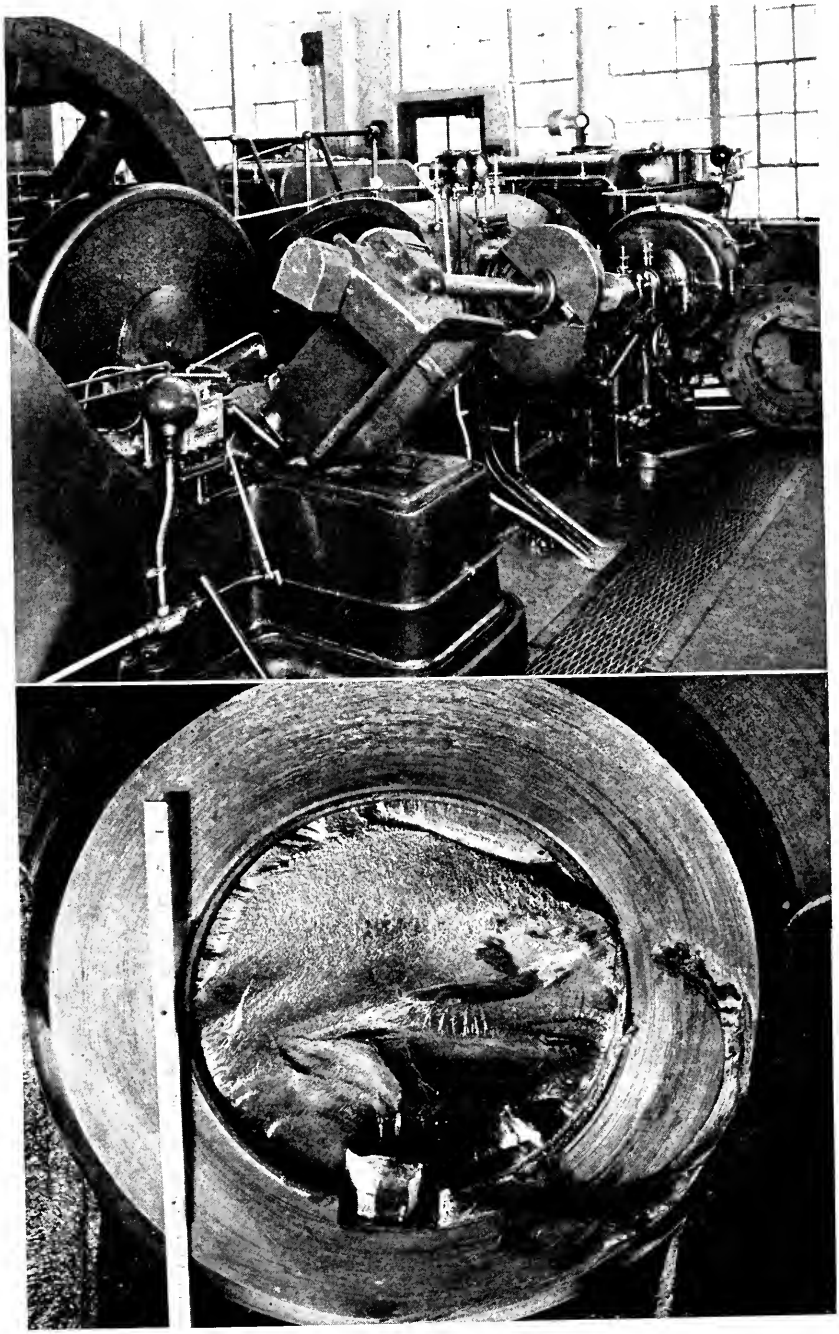
Ammonia Compressor Accident

THE top picture on Page 162 shows some of the damage to a large two-stage steam-driven ammonia compressor after the crankshaft broke. This view was taken from the low-pressure ammonia side looking toward the steam end. As shown in the photograph, the accident resulted in bending of the governor shaft, breaking of the governor gear-drive and housing, and damage to the overspeed tripping wheel which shut down the compressor when it was raised out of position. In addition, other parts not visible in the photograph were broken or damaged. Although the compressor was not insured, from information obtained it was estimated that the total cost of repairs would amount to $5,000.

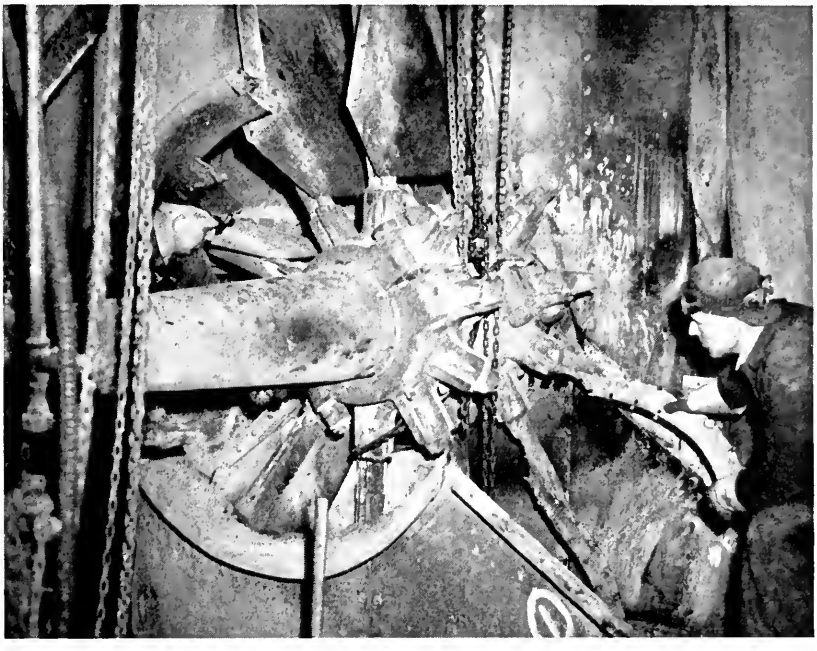
Figure 1—Part of the damage to one-half of a duplex-type induced draft fan, 450 hp capacity. Erosion of the shrouding and excessive temperature of the stack gases caused the accident.
